EXPERIMENTAL STUDY ON BEHAVIOUR OF SHEAR CONNECTORS IN MOMENT RESISTANCE OF STEEL COMPOSITE JOINTS

Feng Fu

Abstract. This paper presents an experimental investigation on the behavior of steel stud connectors in steel composite joints with precast hollowcore slabs in resisting the static bending moment. An experimental program including 5 flexural tests was carried out, and the failure modes of the studs, as well as the shear capacity of stud connectors are investigated. Their contribution to the overall joint moment capacity were studied in depth. The pertinent design recommendation in shear stud design for enhance the moment capacity of the composite joints are also proposed. The testing results and design recommendations presented in this paper can provide basic for future design of composite joints using shear stud connectors with precast slabs

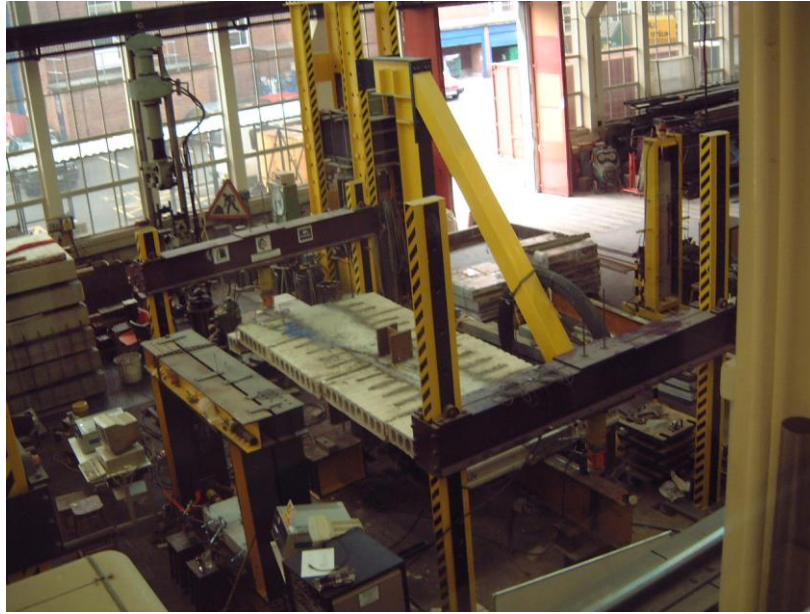
ciform arrangement as shown in Fig. 1 to simulate the internal beam–column joints in a semi-rigid composite frame. The specimen was assembled from two 3300 mm long; $457 \times 191 \times 89$ kg/m; grade S275 universal beams and one $254 \times 254 \times 167$ kg/m; grade S275 universal column to form the cruciform arrangement. The beams are connected to the column flanges using 10 mm thick flush endplates with two rows of M20 Grade 8.8 bolts. The steel connection is a typical connection currently used in UK practice for simple joints, this is to ensure that the enhanced performance of the composite joint is not provided by the bare steel connection. A single row of 19 mm diameter headed shear studs is pre-welded to the top flange of the steel beams.

Figure 1 Test arrangements

Load is applied by hydraulic jacks simultaneously to each ends of the steel beams as shown in Fig. 1 to produce the bending moment of the joints. The load was applied at 10 kN intervals and continued until failure occurred of the joints.

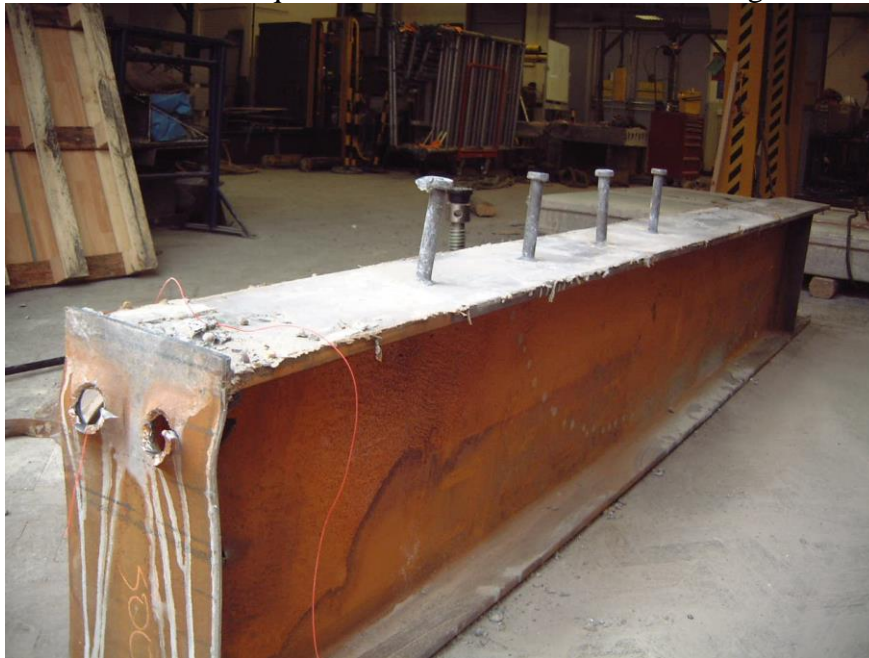
Test CJ6 is full shear interaction case. Figure 5 shows the status of the shear studs after dismantling. It can be seen that, all the studs are remaining intact, but deformation can be observed for all the studs. More severe deformation can be observed in the first stud, and its stud head was squashed. No obvious squash were observed for the remaining 3 studs.

Fig 5 Steel beam after dismantling for CJ6

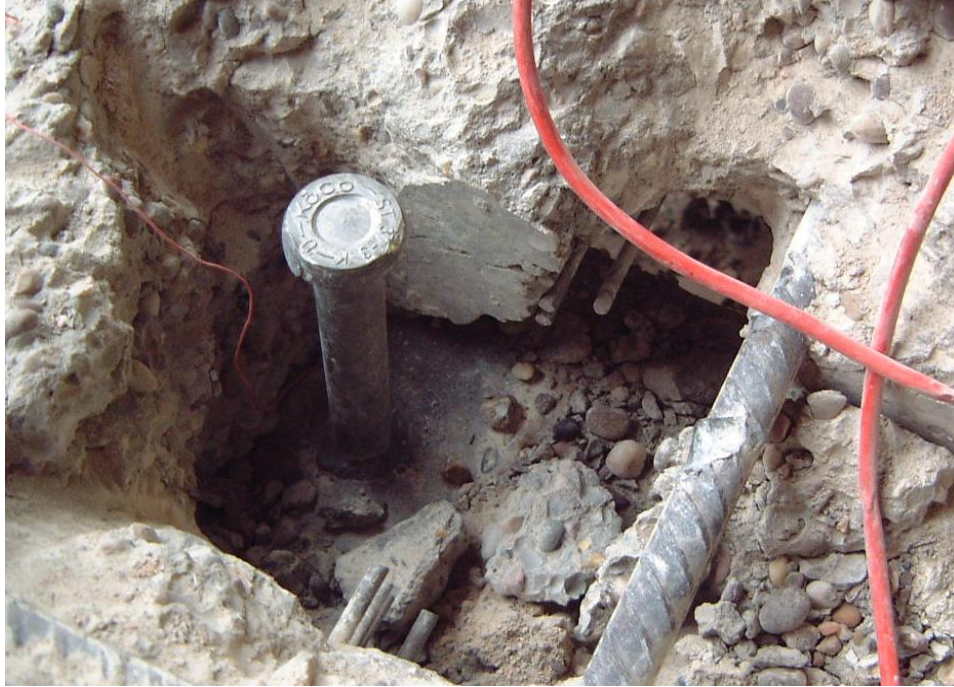
Test CJ7 is also full shear interaction case. Figure 6 shows the status of the shear studs after dismantling. It can be seen that, the studs are remaining intact.

Fig 6 Condition of headed stud after dismantling CJ7
